**Flood Control Project Maintenance
Levee Inspections**
LMA District Cover Sheet
Spring 2018 Levee Inspection Results

Sacramento Maintenance Yard Maintenance Area 0009

Spring 2018 Levee Inspection Results

Waterway	Bank	Unit Miles
Unit No. 01 Sacramento River	Left	19.35

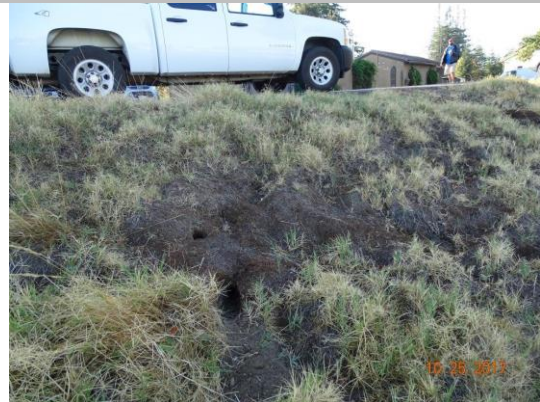
Photo 1 of 4 : SP_2018_MA0009_201_282_20180306_00221.jpg

Updated view of rodent burrows on waterside slope. Fall 2017.

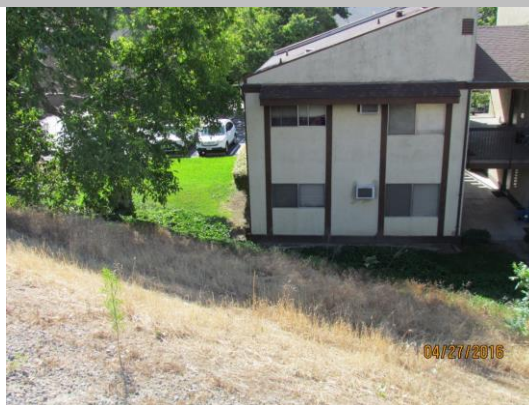
Photo 2 of 2 : SP_2018_MA0009_201_7_20180306_00007.jpg

View of the building on the landward side of the levee. Spring 2016.

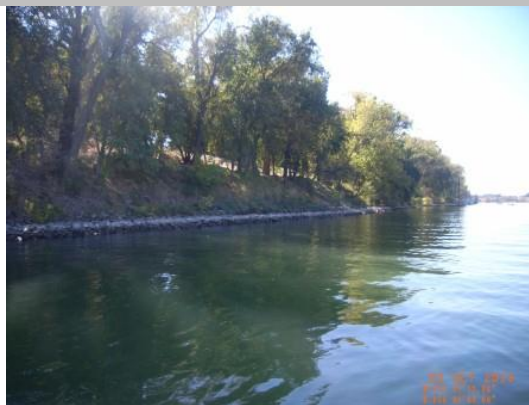
Photo 1 of 2 : SP_2018_MA0009_201_8_20180306_00008.jpg

LM Start	0.70	Rating **	M	Issue No.	8
LM End	0.86	Issue Type +	Ma	Location *	WS
Category	Supplemental			GPS Latitude/Longitude	
				Start	End
Item	2015 USACE Erosion Survey, DRAFT			38.534144 °	38.533143 °
				-121.520263 °	-121.523010 °
DWR ID	DWR_MA0009_01_s_2018_8				
Comment Code					
Inspector Comment					
Site previously named 55.1. 2003 - Pockets of toe erosion at low flow waterline. 2005 - Site renamed 55.2. Still have pockets of erosion but rock bench at waterline is still present. 2010 - Site extended upstream due to new erosion. 2011 - Some of the toe rock has failed. The upper levee slope seems to be slumping. 2012 - Minor new slumping. 2015: No observed changes. [2015 Site ID: SAC 55-2 L]

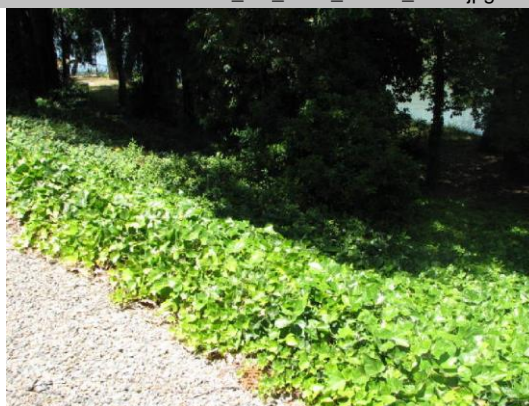
Photo 1 of 2 : UCIP_SP_2018_40523_6122.jpg

LM Start	0.90	Rating **	M	Issue No.	1773	
LM End	0.90	Issue Type +	En	Location *		
Category	Supplemental			GPS Latitude/Longitude		
				Start	End	
Item	DWR UCIP Field Study			38.532640 °	38.532640 °	
				-121.523370 °	-121.523370 °	
DWR ID						
Comment Code						
Inspector Comment						
FS_ID:40523						
DS_ID:17727						
EP_NO: 4809						
Repair Type: Non-Urgent						
Crossing Status: Indicator Found						
UCIP Comments: Could not locate service box due to excessive vegetation (see Pics) Possible electrical conduit crossing at this same location.						
FIELD_STRUCT_DESC: 3/4-inch domestic water supply with valve on land side.						
FS Date: 6/19/2012 2:00:00 PM

Excessive vegetation on waterside.

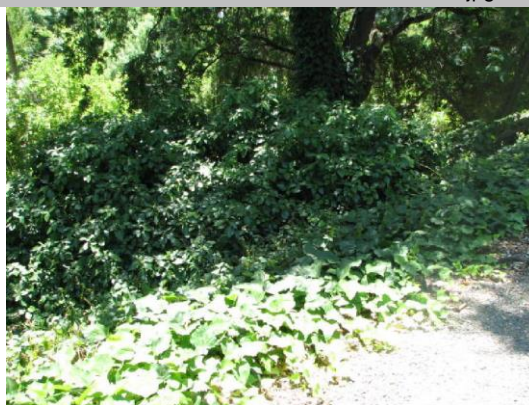
Photo 2 of 2 : UCIP_SP_2018_40523_6121.jpg

Excessive vegetation on landside.

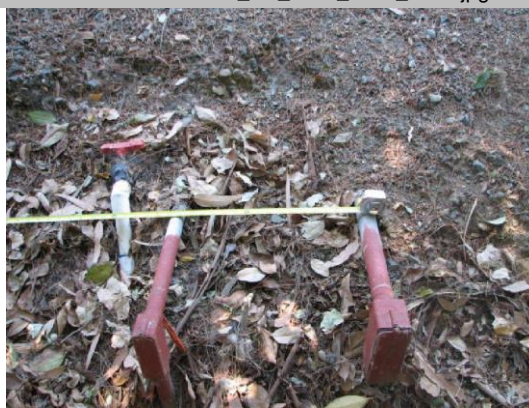
Photo 1 of 3 : UCIP_SP_2018_5843_8911.jpg

LM Start	0.97	Rating **	M	Issue No.	1775
LM End	0.97	Issue Type +	En	Location *	
Category	Supplemental			GPS Latitude/Longitude	
				Start	End
Item	DWR UCIP Field Study			38.532160 °	38.532160 °
				-121.524660 °	-121.524660 °
DWR ID					
Comment Code					
Inspector Comment					
FS_ID:5843 DS_ID:18898 EP_NO: N/A Repair Type: Non-Urgent Crossing Status: Found UCIP Comments: No permit identified for this crossing. FIELD_STRUCT_DESC: 1.5-inch polyvinyl chloride (PVC) electrical conduit through the levee, 1.5 feet below the crown. Light on pole next to irrigation box on the waterside (WS) shoulder. FS Date: 6/19/2012 9:24:40 AM

Pipes on LS slope.

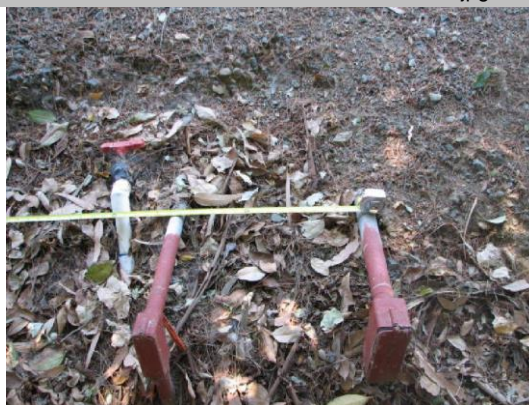
Photo 1 of 2 : UCIP_SP_2018_5845_8916.jpg

LM Start	0.98	Rating **	M	Issue No.	1777
LM End	0.98	Issue Type +	En	Location *	
Category	Supplemental			GPS Latitude/Longitude	
				Start	End
Item	DWR UCIP Field Study			38.532150 °	38.532150 °
				-121.524660 °	-121.524660 °
DWR ID					
Comment Code					
Inspector Comment					
FS_ID:5845 DS_ID:18899 EP_NO: N/A Repair Type: Non-Urgent Crossing Status: Found UCIP Comments: No permit identified for this crossing. FIELD_STRUCT_DESC: 1-inch polyvinyl chloride (PVC) water line through the levee, 1.5 feet below the crown. Shutoff valve on the landside (LS) shoulder. Light on pole next to irrigation box on the waterside (WS) shoulder. FS Date: 6/19/2012 9:32:28 AM

Pipes with shutoff valve on LS slope.

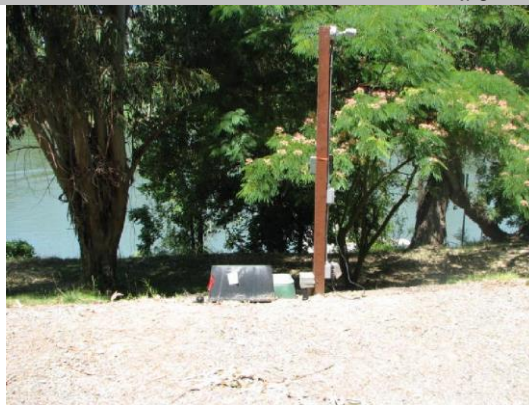
Photo 2 of 2 : UCIP_SP_2018_5845_8915.jpg

WS slope showing christie box on surface with waterline under box at downstream side of light post.

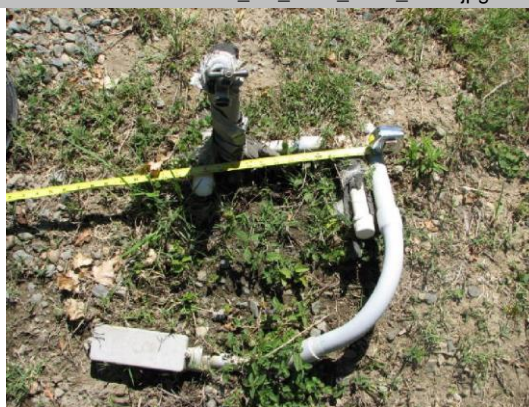
Photo 2 of 3 : UCIP_SP_2018_5848_8920.jpg

Closeup of hose bib.

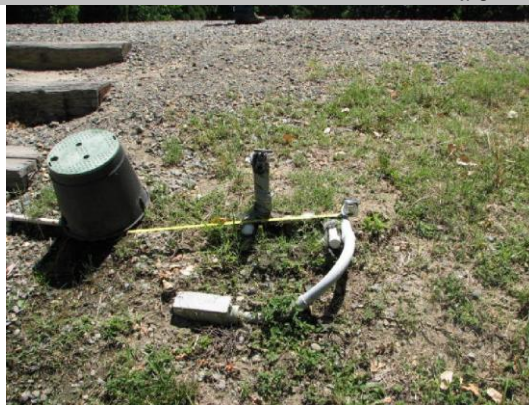
Photo 1 of 2 : UCIP_SP_2018_5849_8923.jpg

Electrical conduit on WS slope.

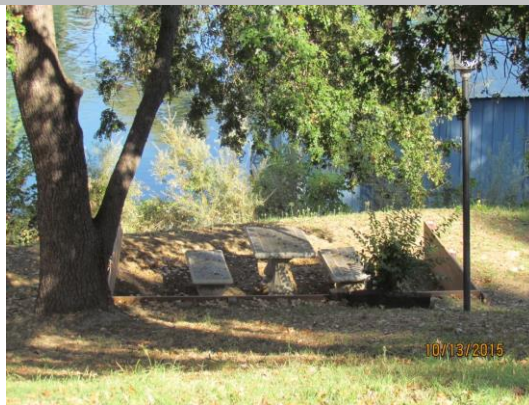
Photo 1 of 1 : SP_2018_MA0009_201_303_20180306_00243.jpg

View of the table and retaining wall on the waterward side of the levee. Fall 2015.

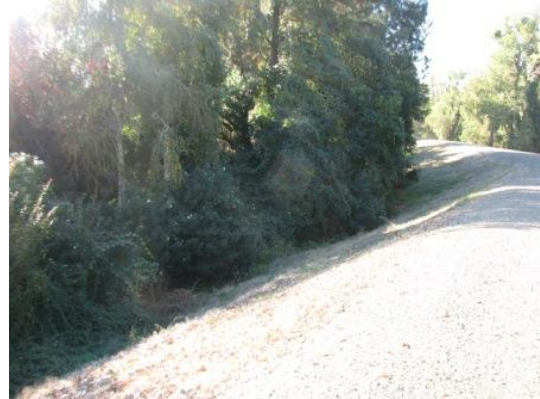
Photo 1 of 2 : SP_2018_MA0009_201_33_20180306_00022.jpg

The trees and woody vegetation blocks visibility. Fall 2013

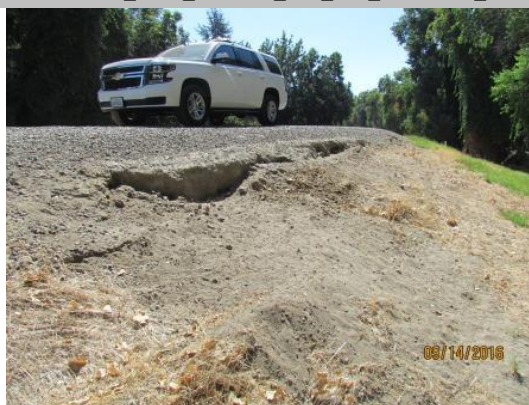
Photo 1 of 2 : SP_2018_MA0009_201_312_20180306_00247.jpg

Erosion site on the waterward side of the levee. Fall 2016 inspection.

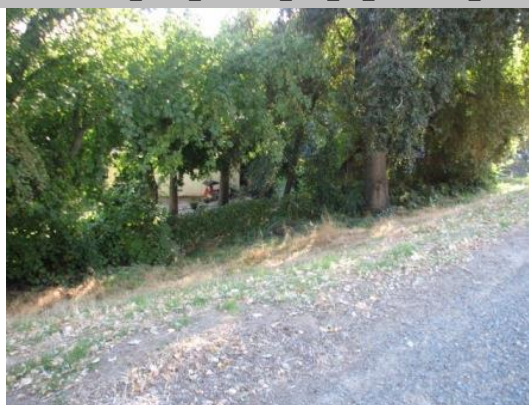
Photo 1 of 2 : SP_2018_MA0009_201_22_20180306_00018.jpg

Vegetation grows on the fence and blocks visibility. Fall 2013

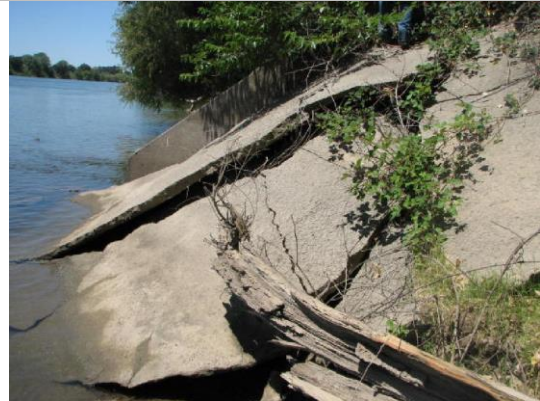
Photo 1 of 3 : UCIP_SP_2018_4703_6128.jpg

Broken up concrete apron on downstream side of outlet

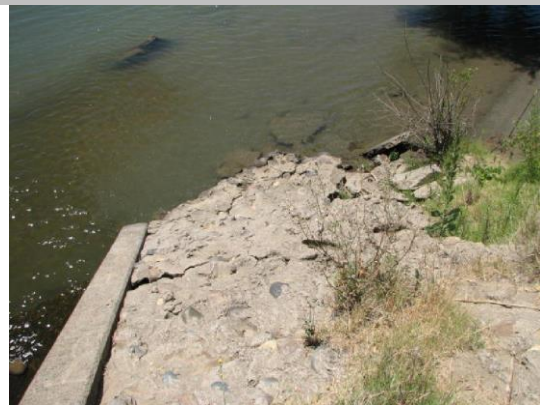
Photo 2 of 3 : UCIP_SP_2018_4703_6127.jpg

Broken up concrete apron on upstream side of outlet

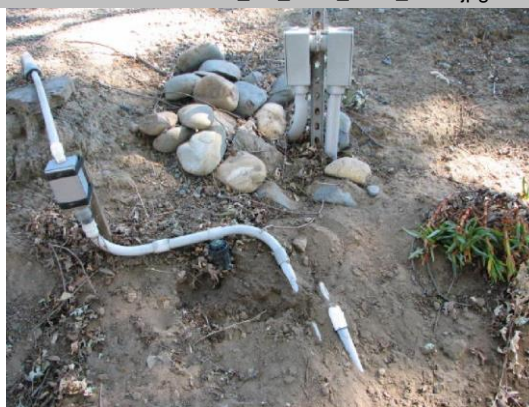
Photo 2 of 2 : UCIP_SP_2018_5860_8945.jpg

Pipes visible on LS slope approximately 50-feet downstream from pier walkway.

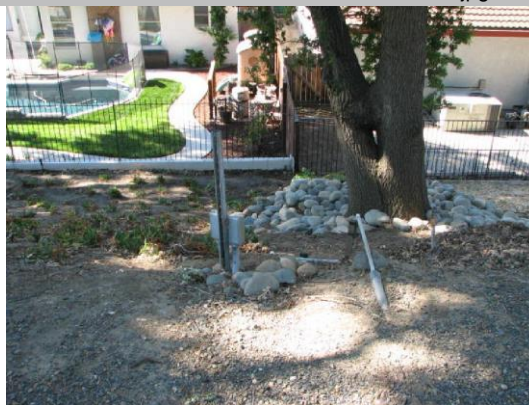
Photo 2 of 2 : UCIP_SP_2018_5854_8933.jpg

Pipes on LS slope approximately 50-feet downstream from walkway/pier.

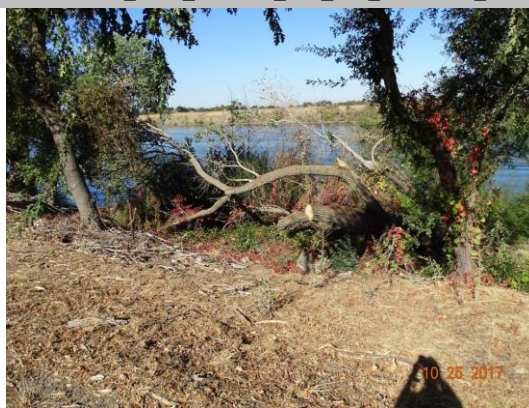
Photo 1 of 1 : SP_2018_MA0009_201_270_20180306_00217.jpg

View of fallen tree on waterside slope. Fall 2017.

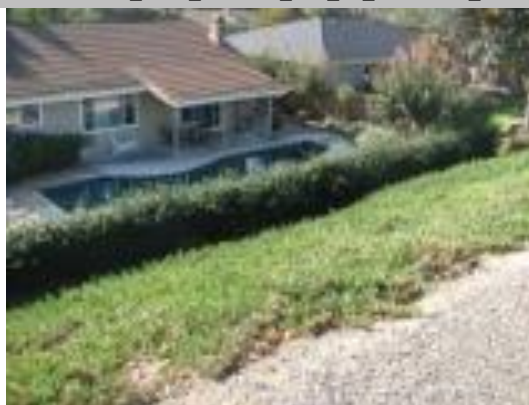
Photo 1 of 1 : SP_2018_MA0009_201_69_20180306_00038.jpg

A fence and retaining wall with star jasmine growing on it blocks view of the toe. Fall 2011

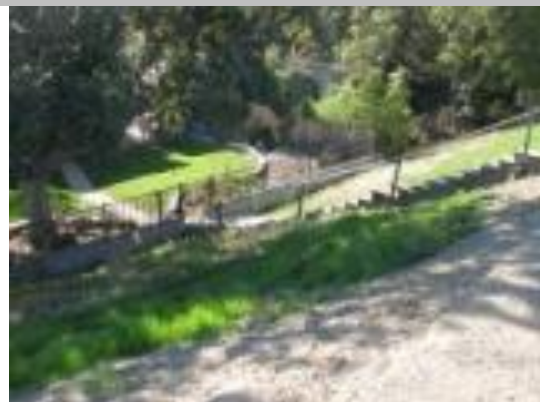
Photo 1 of 2 : SP_2018_MA0009_201_70_20180306_00039.jpg

Wall built along toe of levee. Fall 2012

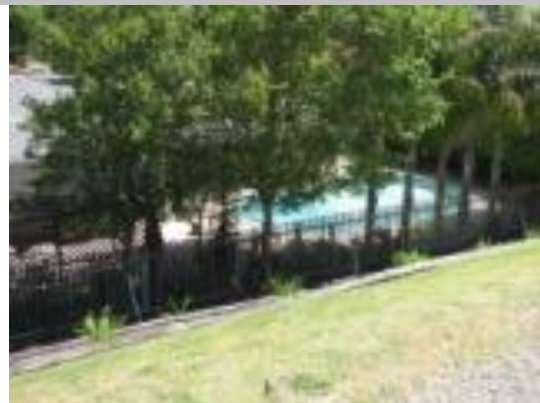
Photo 1 of 1 : SP_2018_MA0009_201_121_20180306_00072.jpg

The levee slope has been terraced and with a small retaining wall, fence and landscape. Spring 2013

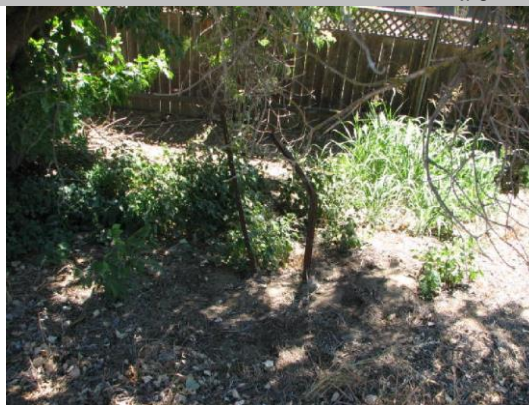
Photo 2 of 3 : UCIP_SP_2018_5760_8722.jpg

Two t-posts may indicate pipe location on LS slope.

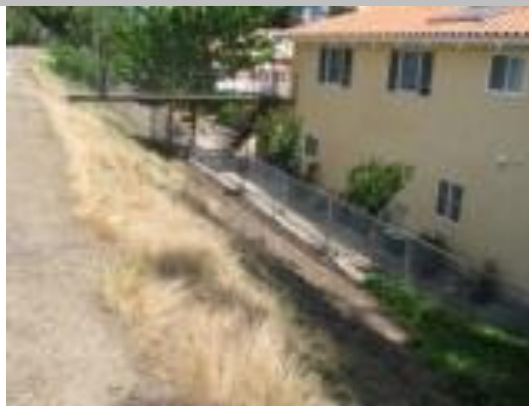
Photo 1 of 2 : SP_2018_MA0009_201_135_20180306_00086.jpg

A retaining wall with a fence on top and some groundcover. Photo taken spring 2012.

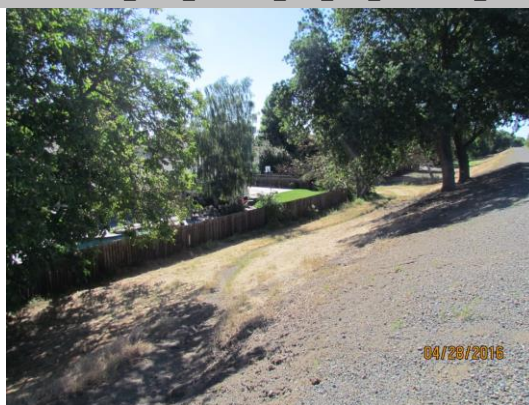
Photo 1 of 1 : SP_2018_MA0009_201_153_20180306_00105.jpg

View of the the wooden fence at the toe of the levee on the landward side looking downstream. Spring 2016.

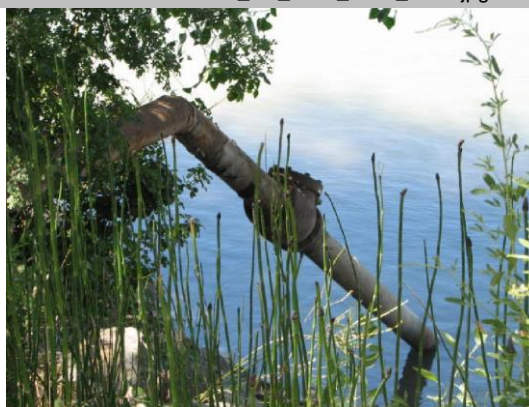
Photo 2 of 3 : UCIP_SP_2018_4980_6629.jpg

Pipe entering water at WS toe

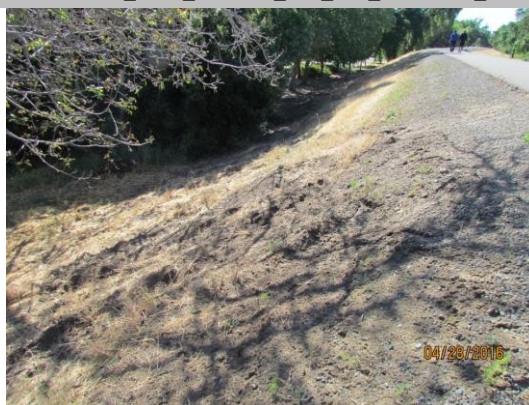
Photo 1 of 1 : SP_2018_MA0009_201_369_20180306_00300.jpg

View of the footpath on the landward side of the levee looking downstream. Spring 2016.

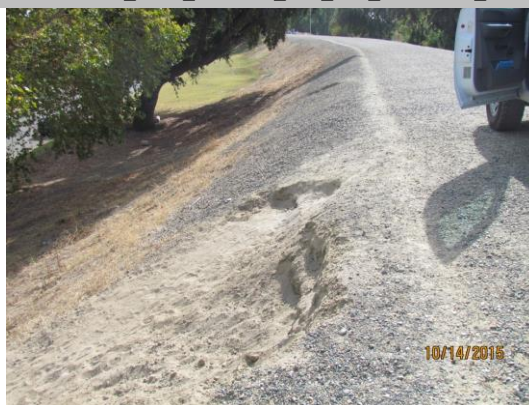
Photo 2 of 2 : SP_2018_MA0009_201_337_20180306_00275.jpg

View of the slope stability caused by foot traffic on the landward side of the levee looking downstream. Fall 2015.

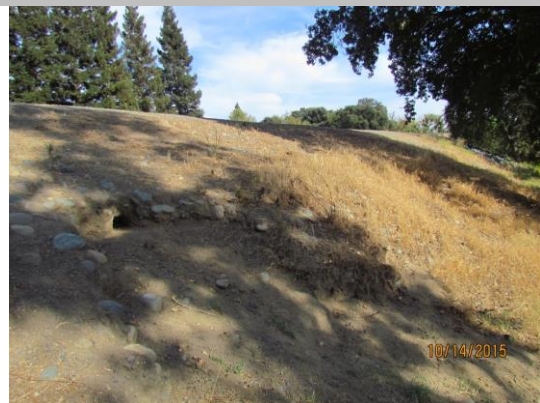
Photo 1 of 1 : SP_2018_MA0009_201_341_20180306_00279.jpg

View of the slope stability caused by foot traffic on the waterward side of the levee looking downstream. Fall 2015.

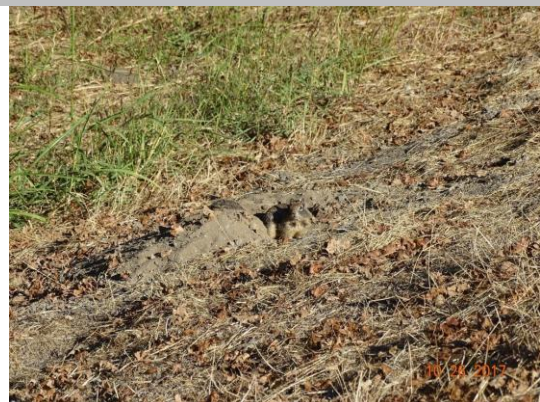
Photo 1 of 2 : SP_2018_MA0009_201_418_20180306_00314.jpg

View of squirrel in hole on landside slope. Fall 2017.

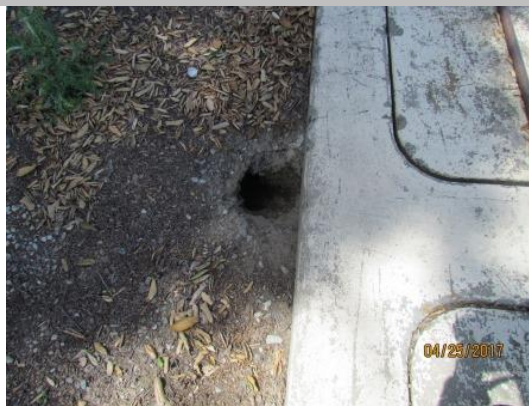
Photo 1 of 1 : SP_2018_MA0009_201_290_20180306_00226.jpg

View of rodent hole on landside shoulder. Spring 2017.

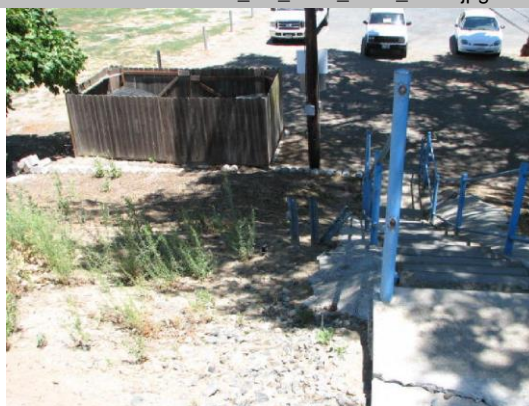
Photo 2 of 2 : UCIP_SP_2018_5904_8968.jpg

Pipe buried 3-feet upstream from top of stairs on LS slope.

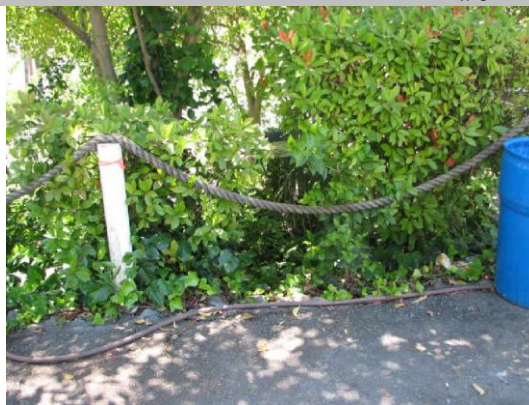
Photo 3 of 3 : UCIP_SP_2018_5107_6814.jpg

Pipe on WS slope just upstream from stairs.

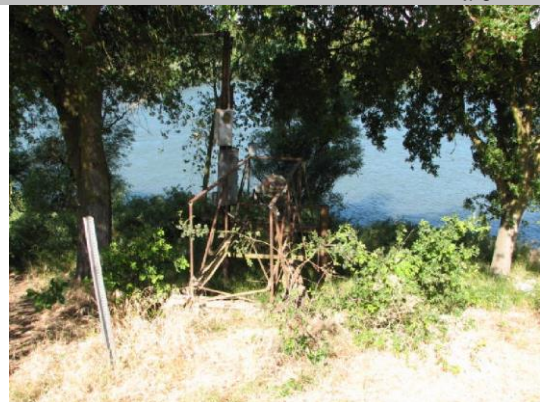
Photo 1 of 3 : UCIP_SP_2018_5117_6830.jpg

Walkway in total disrepair at pump on WS.

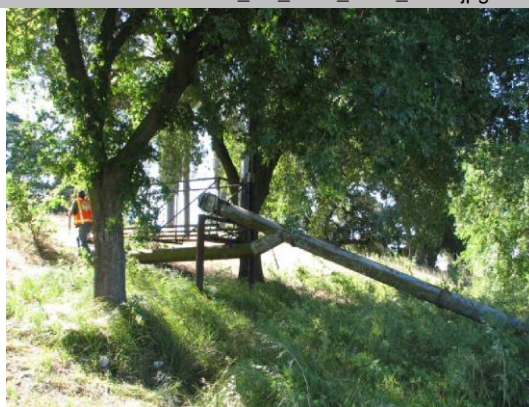
Photo 3 of 3 : UCIP_SP_2018_5117_6828.jpg

Pump and pipe on WS of levee.

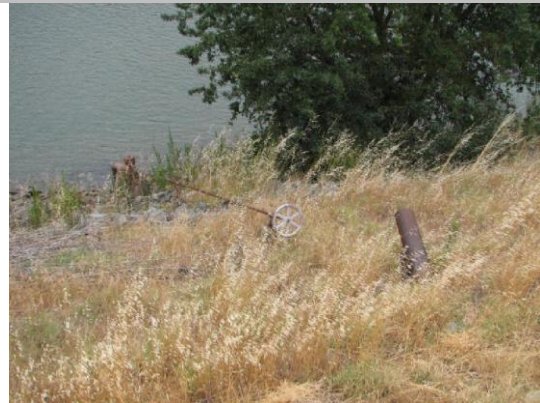
Photo 1 of 1 : UCIP_SP_2018_5162_6965.jpg

6-inch steel pipe grouted in place 3.5-feet below the crown.

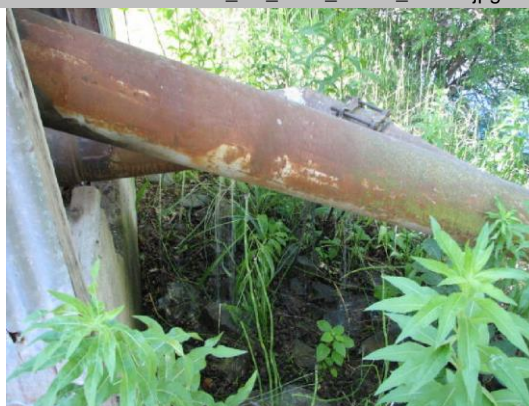
Photo 2 of 3 : UCIP_SP_2018_51464_20798.jpg

Holes/leaks in pipe on WS of Pumphouse.

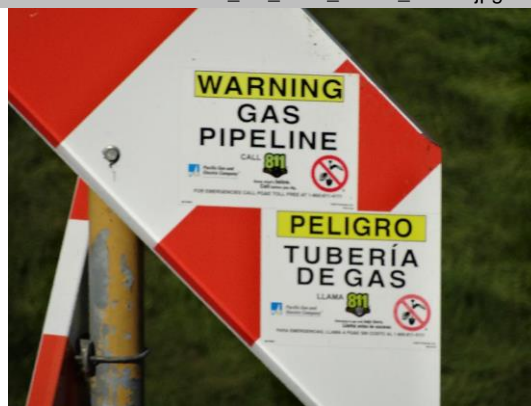
Photo 2 of 3 : UCIP_SP_2018_51260_76343.jpg

PG&E line markers visible along LS toe.

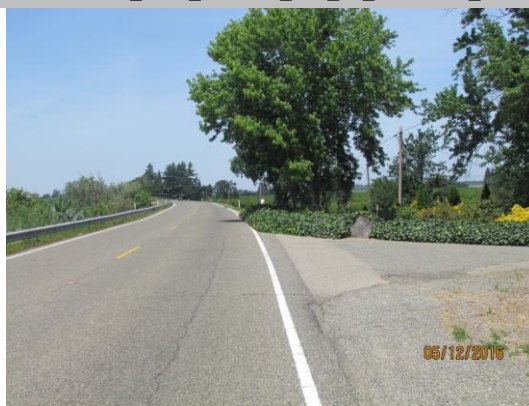
Photo 1 of 1 : SP_2018_MA0009_201_55_20180306_00034.jpg

View of the trees and ivy plants on the shoulder of the levee on the landward side looking upstream. Spring 2016.

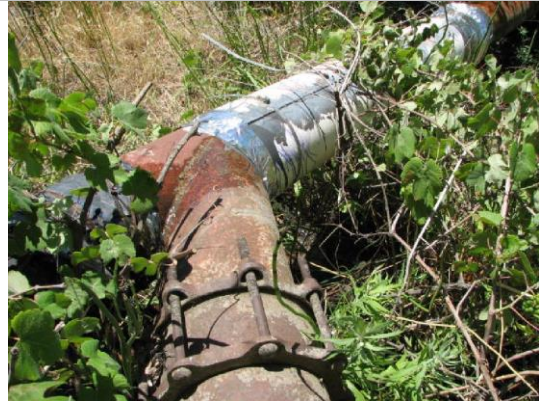
Photo 3 of 3 : UCIP_SP_2018_51465_20807.jpg

Pipe holes and patch job typical of large sections of pipe.

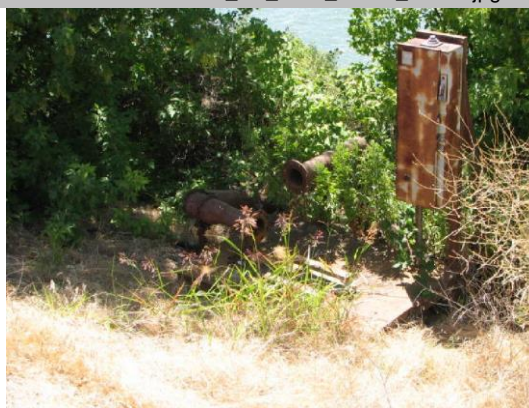
Photo 1 of 3 : UCIP_SP_2018_51256_20814.jpg

WS shoulder: pumphouse missing walls, pump, and gate valve

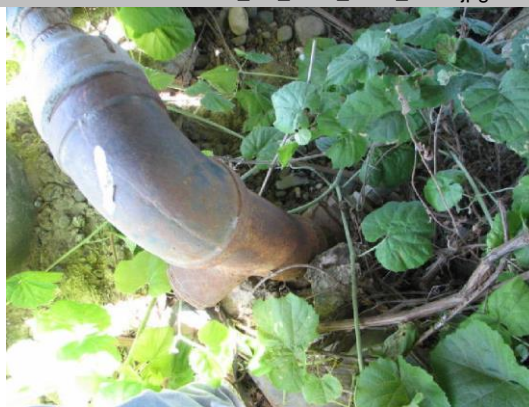
Photo 1 of 3 : UCIP_SP_2018_5933_9043.jpg

Pipe under walkway of building on WS slope.

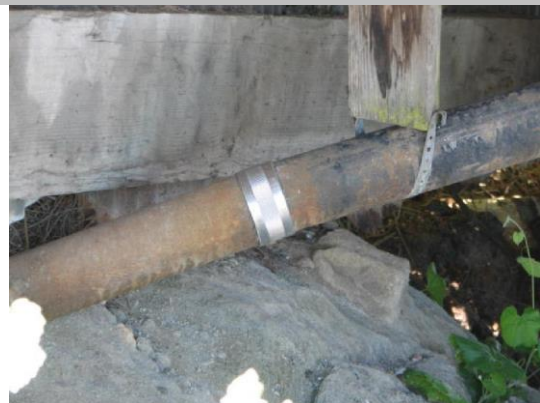
Photo 1 of 2 : UCIP_SP_2018_5938_9052.jpg

Pipe through levee on WS slope.

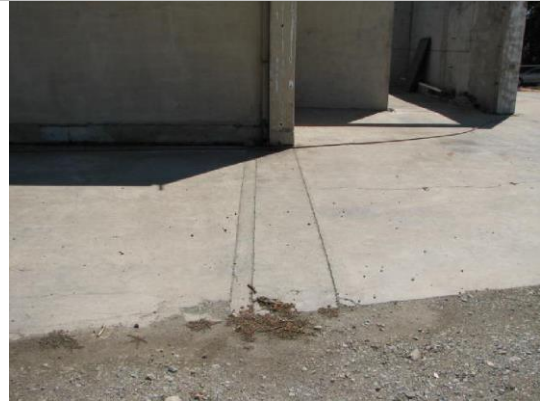
Photo 2 of 2 : UCIP_SP_2018_5939_9053.jpg

cut through concrete at building on LS shoulder where waterline was installed (per inspector).

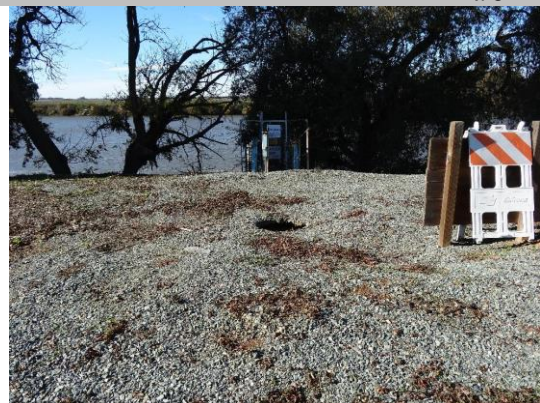
Photo 2 of 3 : UCIP_SP_2018_51466_76372.jpg

WS view: Sink hole present along pipe alignment.

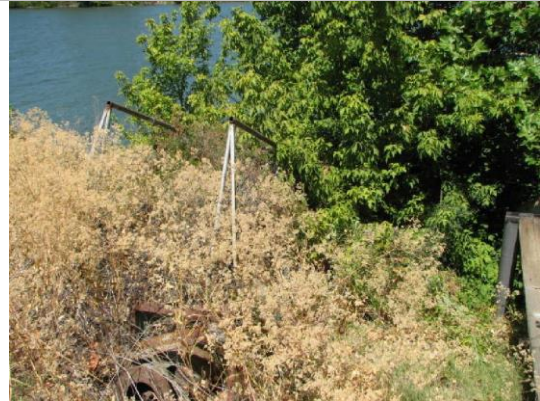
Photo 3 of 3 : UCIP_SP_2018_51259_20816.jpg

Discarded metal walkway ramp and slant pump appurtenances on WS slope.
